## Paint and Corrosion Stripping – Case Study

### Fletcher Cresco, Wanganui Aeroworks

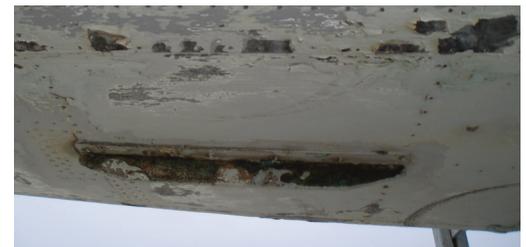
Wanganui Aeroworks, a company which specialised in all aspects of aerial applications such as fertiliser spreading and agriculture spraying, required removal of filiform corrosion and ceramic undercarriage coatings on an Ag-Aircraft.

Corrosion and Ceramic Coatings

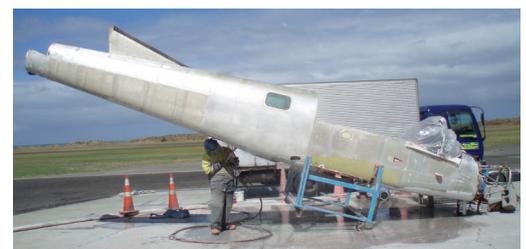
Coatings Stripped from Aircraft

The waterjetting process done by the Aquamax team stripped the Ag-Aircraft clean from the coatings that required removal, including the painting, leaving it primed for a renewal job and delighting the client with the efficiency and quality of professional waterjetting.
